Sample Survey

Loss Control Supplemental Report

| Name of Risk: | Sample Risk | |
| Survey Date: | January 5, 20XX | |

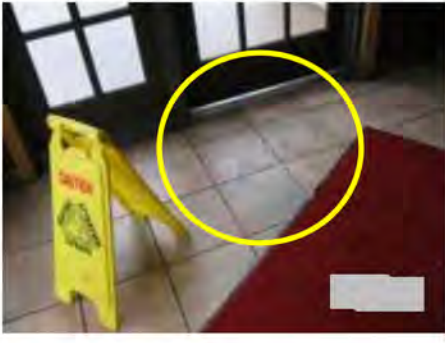
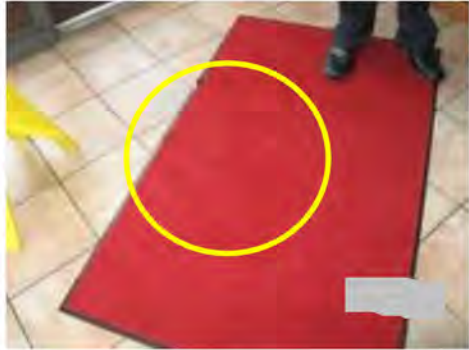
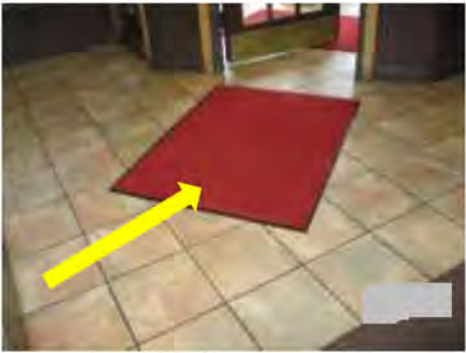
| <p>Item Number: XX-01-01</p> <p>Location: Front Entrance</p> <p>Observation: The area of coverage by the slip resistant matting was inadequate due to inadequately placed or damaged mats creating a Slip & Fall Hazard in these areas.</p> <p>A formal mat policy should be implemented that includes, inspection, areas of use with adequate coverage, maintenance and replacement once the mats are no longer considered to be serviceable.</p> | | |

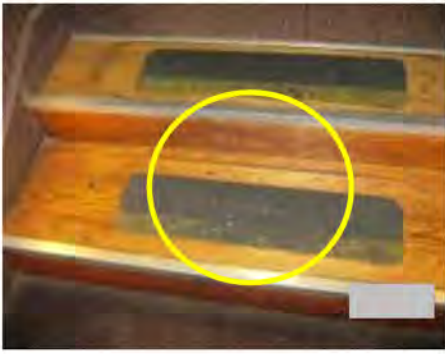
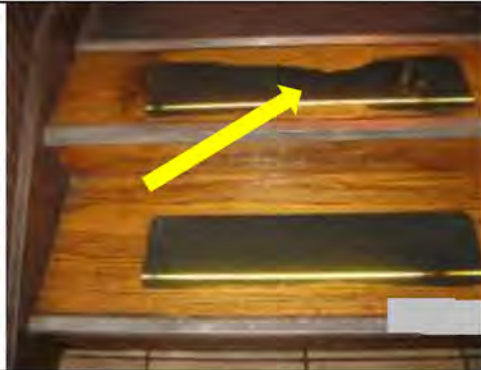
| <p>Item Number: XX-01-02</p> <p>Location: Dining Room Steps</p> <p>Observation: The slip resistant material on the steps was worn due to normal wear and tear creating a Slip & Fall Hazard to patrons using these steps.</p> <p>All the steps in the restaurant should be inspected and repaired.</p> | | |

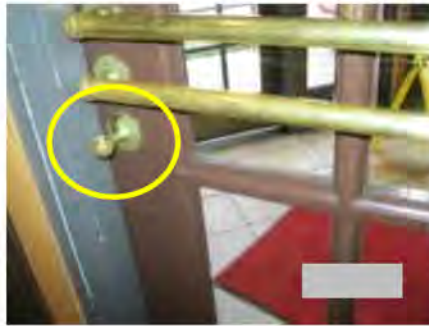
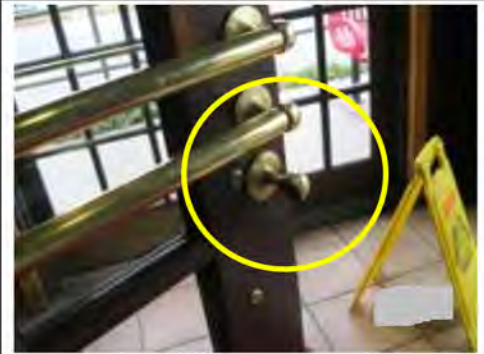
Item Number: XX-01-03

Location: Front Entrance

Observation: The brass door railing was found to be damaged creating a Personal Injury Hazard to patrons using this doorway.

The door should be inspected and repaired by a qualified contractor.

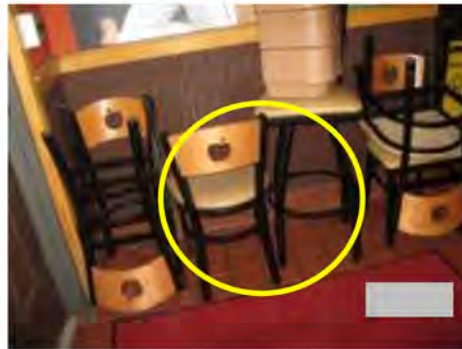
Item Number: XX-01-04

Location: Dining Area

Observation: Excess furniture storage was observed creating a Trip & Fall Hazard to persons in the walkway area.

All such storage should be relocated as not to impede the flow of pedestrian traffic.

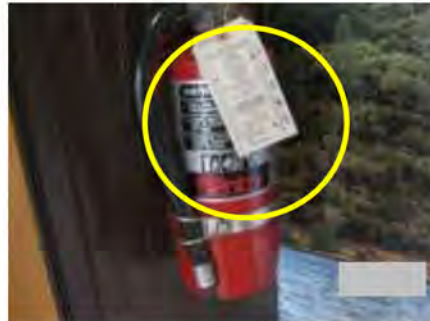
Item Number: XX-01-05

Location: Dining Area

Observation: The fire extinguisher tag was found to be expired.

A certified fire extinguishing contractor should inspect and service all such equipment as per NFPA 10 Guidelines.

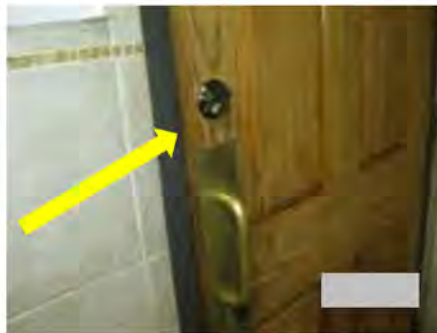
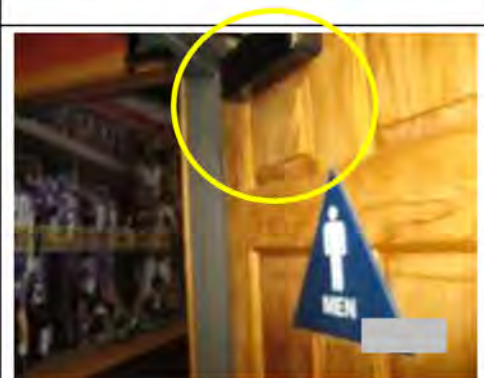
Item Number: XX-01-06

Location: Men's Restroom

Observation: The restroom door was found to be damaged and not closing properly creating a Personal Injury Hazard.

A certified carpenter should be retained to make the necessary repairs.

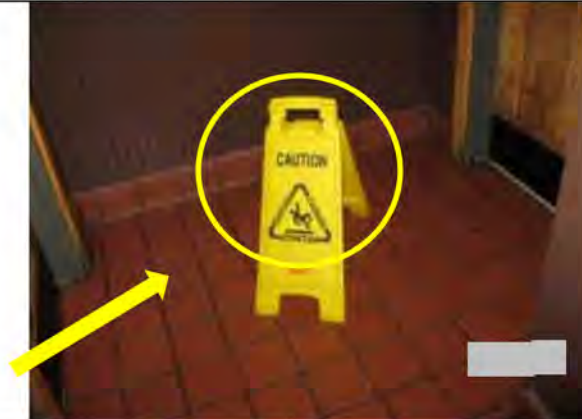
Item Number: XX-01-07

Location: Restroom Hallway

Observation: The restroom hallway tile was found to be wet creating a Slip & Fall Hazard to patrons in this area.

Anti-slip matting should be installed in this area and maintained on a regular basis.

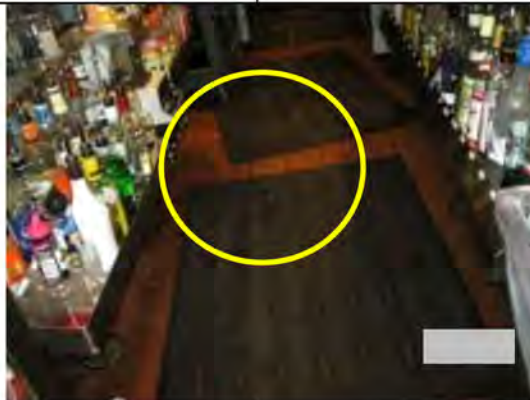
Item Number: XX-01-08

Location: Bar Area

Observation: The matting behind the bar was improperly installed with gaps in coverage creating a Trip & Fall Hazard to employees in this area.

Matting should be provided with adequate coverage over the entire traveled surface area of the bar area.

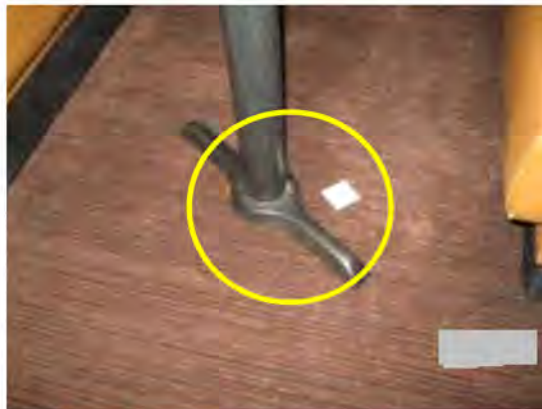
Item Number: XX-01-09

Location: Dining Area

Observation: The table supports were not adjusted properly thus creating an imbalance of the tabletop.

This could cause the table to tip over creating a Personal Injury Hazard.

All tables should be inspected and repaired as required to eliminate this exposure.

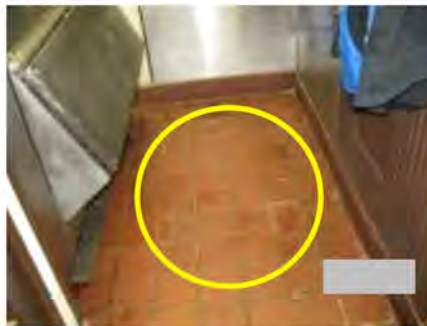
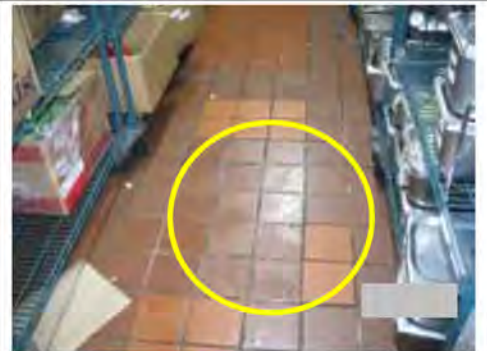
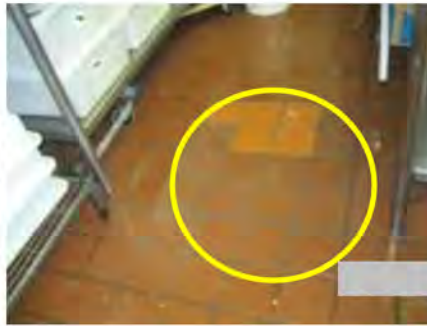
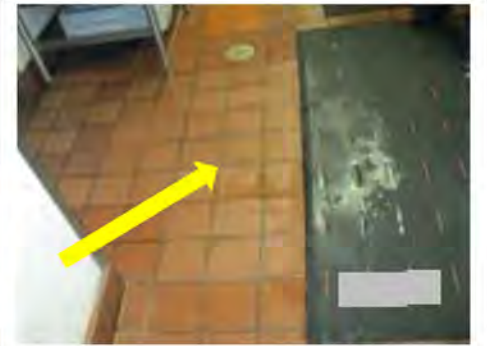
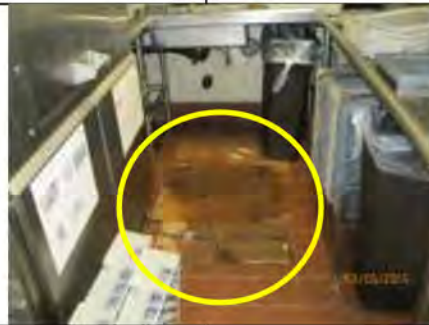
Item Number: XX-01-10

Location: Various Kitchen Areas

Observation: The area of coverage by the slip resistant matting was inadequate due to being inadequately placed or damaged, creating a Slip & Fall Hazard in these areas.

A formal mat policy should be implemented that includes, inspection, areas of use with adequate coverage, maintenance and replacement once the mats are no longer considered to be serviceable.

Note: A matting location plan should be implemented for all locations so management is aware where matting is required.

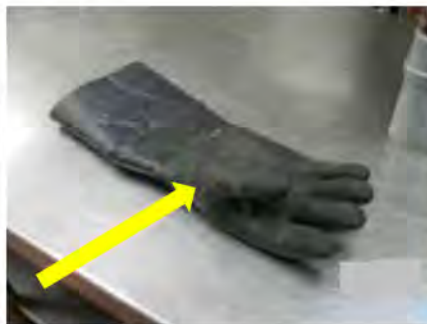
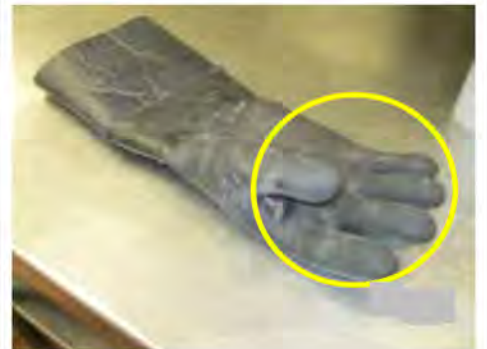
Item Number: XX-01-11

Location: Kitchen

Observation: PPE (personal protective equipment) was found to be either damaged and/or soiled as to affect their effectiveness in everyday use.

A Corporate PPE Program should be developed and implemented that takes into consideration the need, use, storage, inspection, maintenance and replacement of all such equipment on a regular basis.

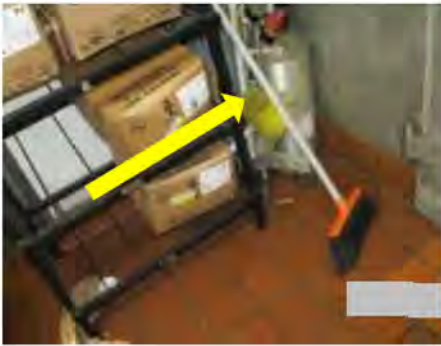
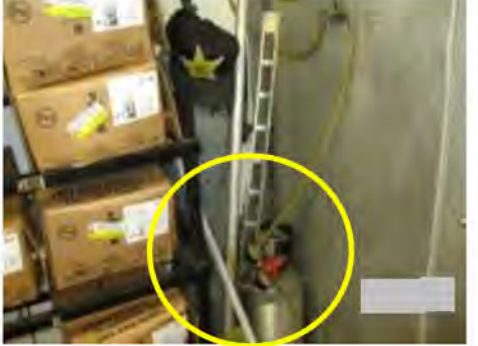
| <p>Item Number: XX-01-12</p> <p>Location: Entire Area</p> <p>Observation: There is no standardized floor cleaning procedure including the use of chemicals as well as the use, storage and maintenance of equipment.</p> <p>This condition causes excessive grease accumulation on the walking surfaces creating a Slip & Fall Exposure on all walking surfaces.</p> <p>A new procedure should be developed and implemented as soon as possible.</p> | | |

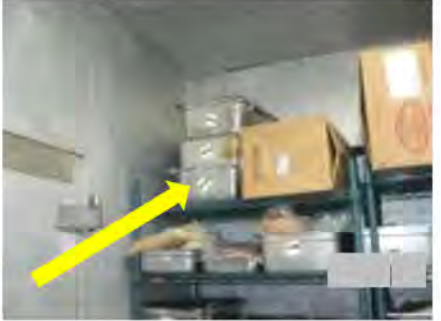
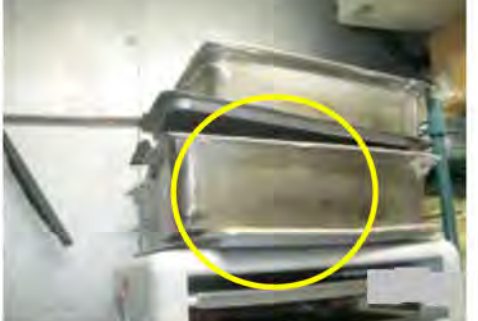
| <p>Item Number: XX-01-13</p> <p>Location: Walk-In Units</p> <p>Observation: Storage of heavy metal food trays were improperly stored creating Falling Object Exposure to employees in this area.</p> <p>All such heavy food trays should be stored at a lower elevation to eliminate this exposure.</p> | | |

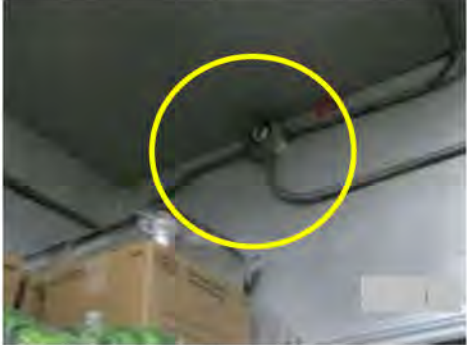
| <p>Item Number: XX-01-14</p> <p>Location: Walk-In Unit</p> <p>Observation: The electrical light socket was open and exposed creating an Electrical Shock Hazard to employees coming in contact with same.</p> <p>The light socket should be repaired and its protective cover be replaced.</p> | | |

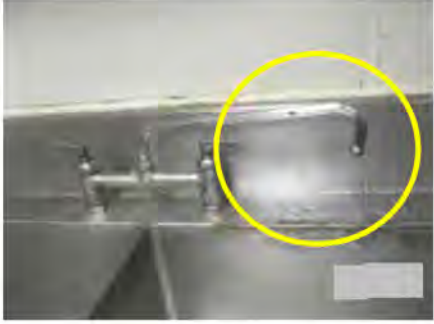
| <p>Item Number: XX-01-15</p> <p>Location: Kitchen</p> <p>Observation: The faucet was observed being damaged allowing water to constantly flow.</p> <p>A certified plumber should be retained to inspect all the faucets in the restaurant and make the necessary repairs.</p> | | |

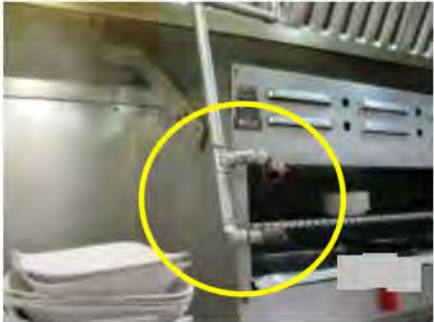
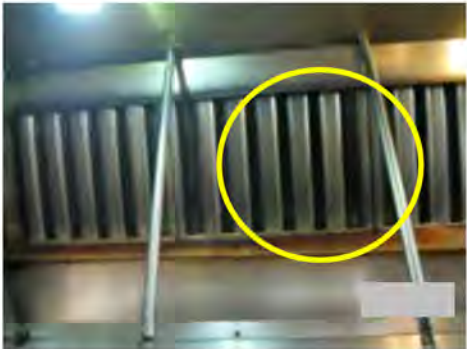
Item Number: XX-01-16

Location: Cook Line

Observation: The AES nozzles on some of the equipment are not aimed properly towards the source of the flame creating a Fire Hazard.

The AES vendor should be contracted to make the necessary repairs.

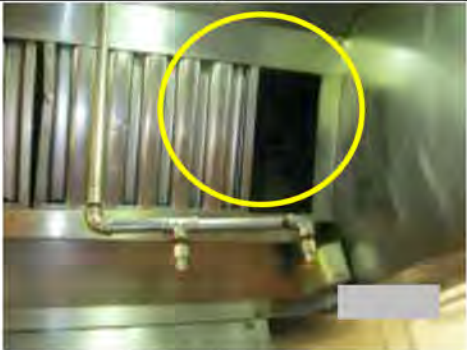
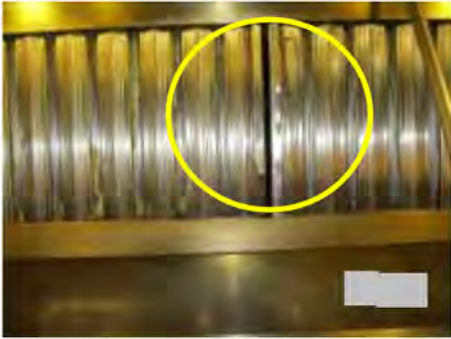
Item Number: XX-01-16

Location: Kitchen Exhaust Hood

Observation: The hood baffles in the exhaust system were either damaged or improperly installed allowing grease to enter the exhaust system creating Fire Hazard.

All the baffles should be inspected and replaced as required to have a solid exhaust flow through the filters baffles.

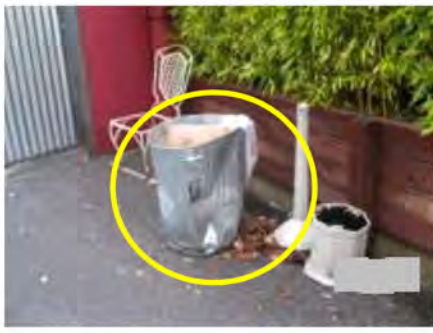
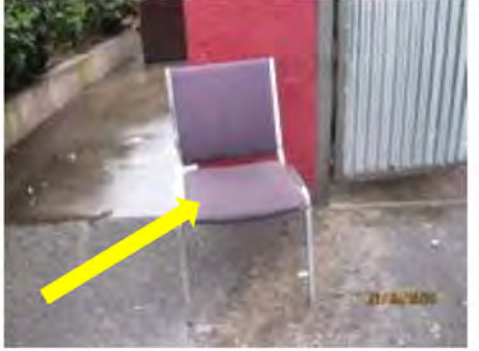
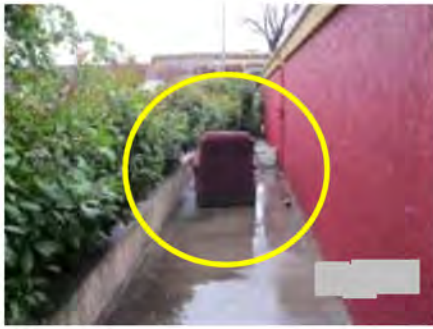
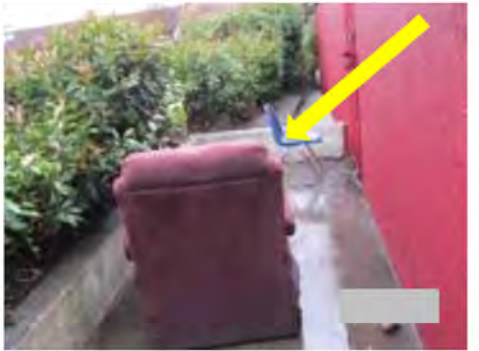
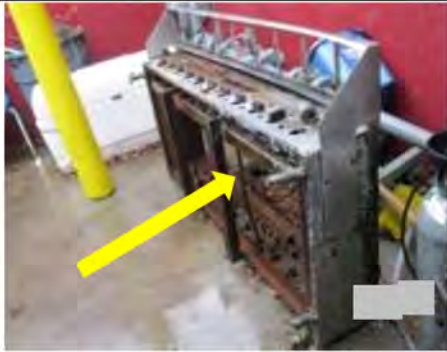
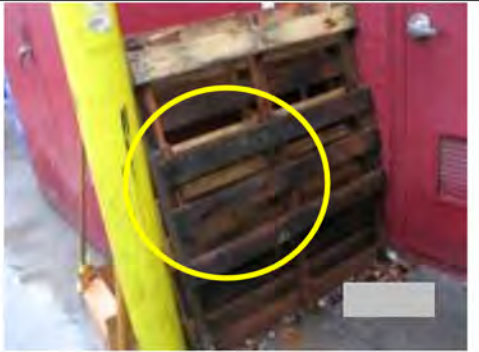
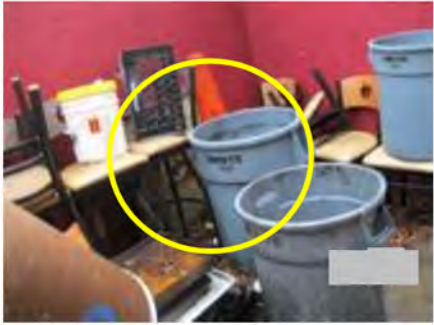
Item Number: XX-01-18

Location: Side and Rear of Building

Observation: There was an unusual amount of combustible and non-combustible refuse stored on the side of the building.

This creates an Attractive Nuisance Hazard as well as a Personal Injury Hazard to persons coming in contact with this equipment.

All such superfluous refuse should be removed and the area kept clean at all times to eliminate this exposure.

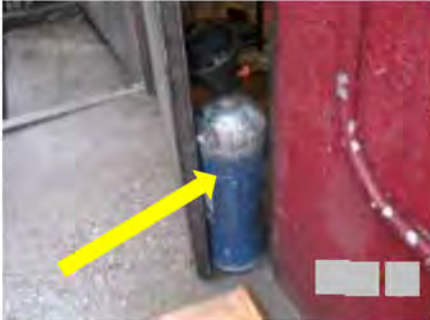
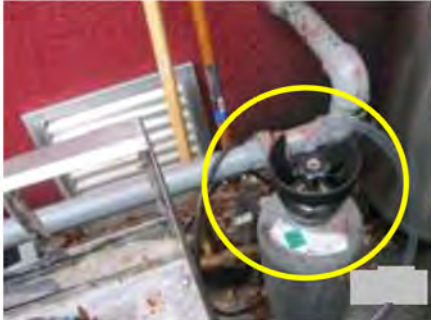
Item Number: XX-01-19

Location: Outside Storage Area

Observation: CO2 cylinder was found to be improperly protected against falling.

All CO2 Cylinders should be adequately secured by a chain to prevent them from falling and shearing off its valve as required by OSHA – General Industry Standards 29 CFR 1910.

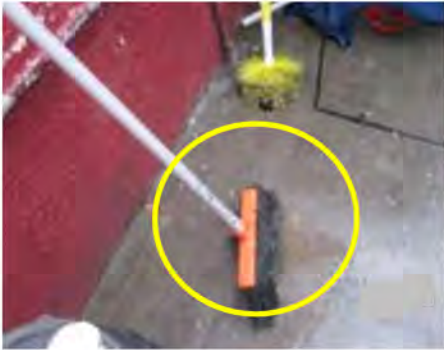
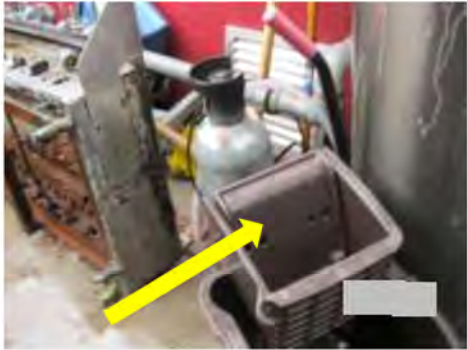
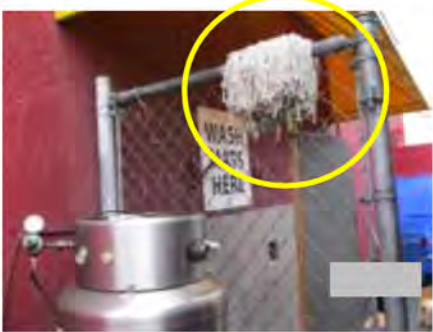
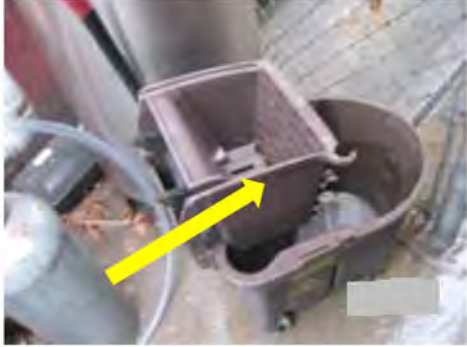
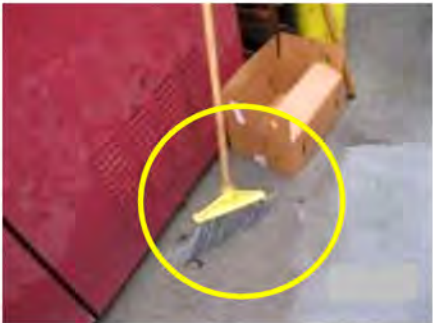
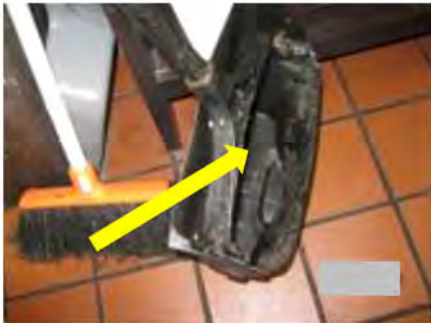
Item Number: XX-01-20

Location: Entire Area

Observation: There is no standardized floor cleaning procedure being followed, including the use of chemicals as well as the use, storage and maintenance of equipment.

This condition causes excessive grease accumulation on the walking surfaces creating a Slip & Fall Exposure on all walking surfaces.

A new procedure should be developed and implemented as soon as possible.
