Claim Number:	987-654-321
Claimant:	John Q. Public Jr.
Insured:	Restaurant Group
Date of Loss:	XX-XX-XXXX

Claims Investigation

Re: Claim No ICC12345
Claimant John Q. Public, Jr.
Insured Restaurant Group
D/L
Investigation date:

Please select type of loss GL
If GL, please choose type of loss. If more than one loss, please select "other" and explain Slip/Trip Fall
Assignment On I was assigned to conduct an on scene investigation of the above alleged incident, including photographing the scene, identifying and interviewing any witnesses and to determine if any surveillance video exists.
Claim Claimant John Q. Public alleged he tripped and fell on a sewer grate on the sidewalk in front of Restaurant, 123 Main Street, . This allegedly occurred on
Location of Loss
Contact

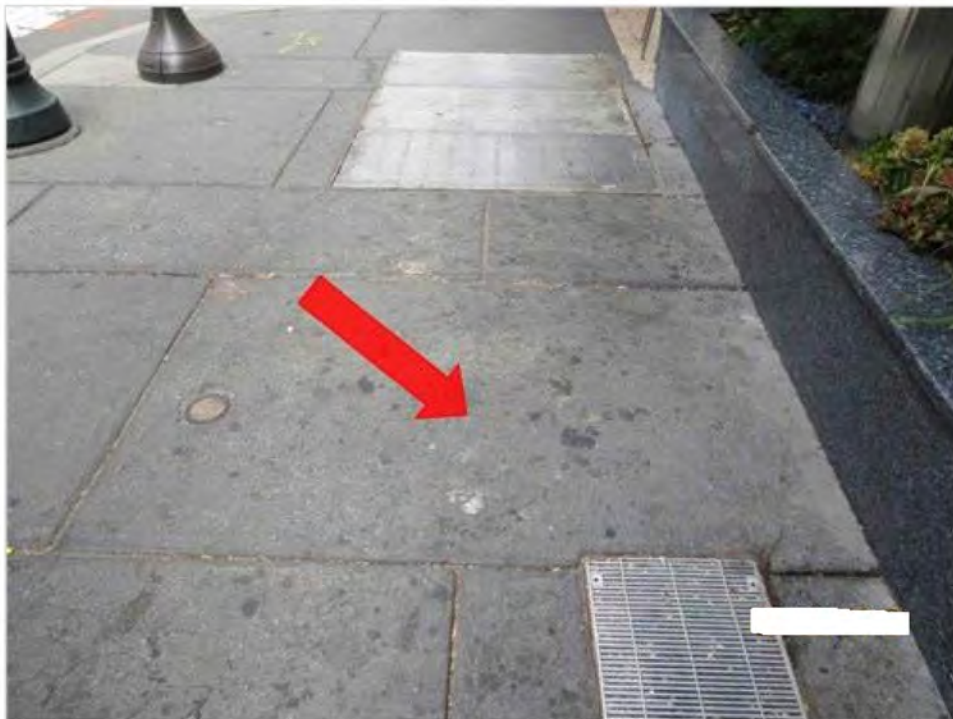
When asked to describe her further he could only provide that [redacted] was wearing flat shoes. I requested him to show me the exact location where the [redacted] allegedly stumbled and fell. He directed me to the flat sidewalk area immediately before the sidewalk grate in question. He added that she didn't trip on the grate but fell onto it after stumbling on the flat sidewalk slab prior to it.

Location That Witness

Indicated Claimant Stumbled

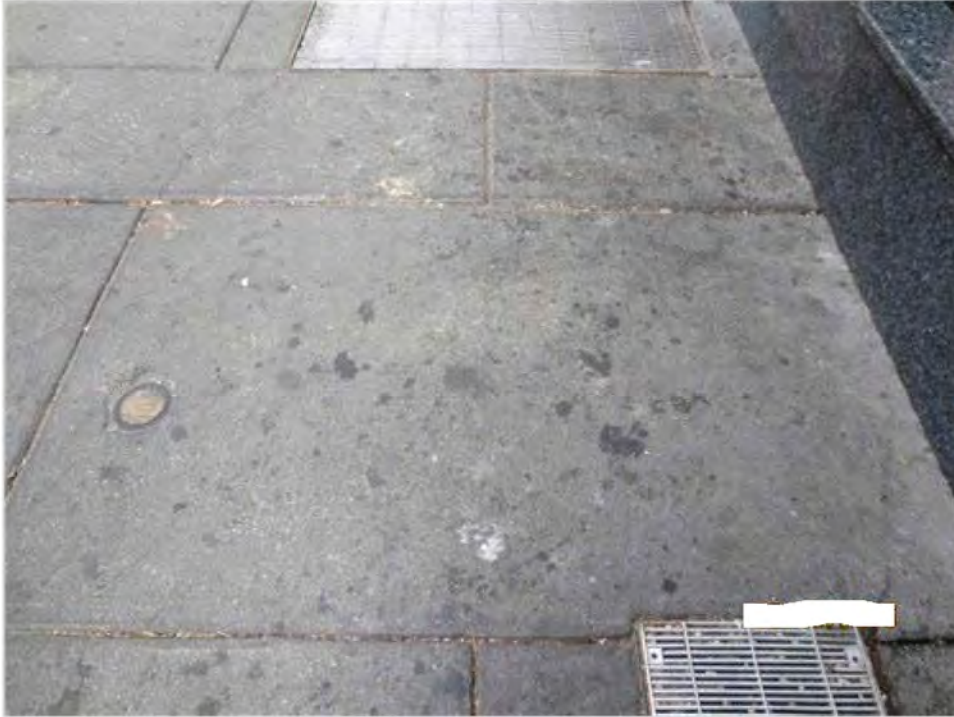
Close Up of Previous Photo

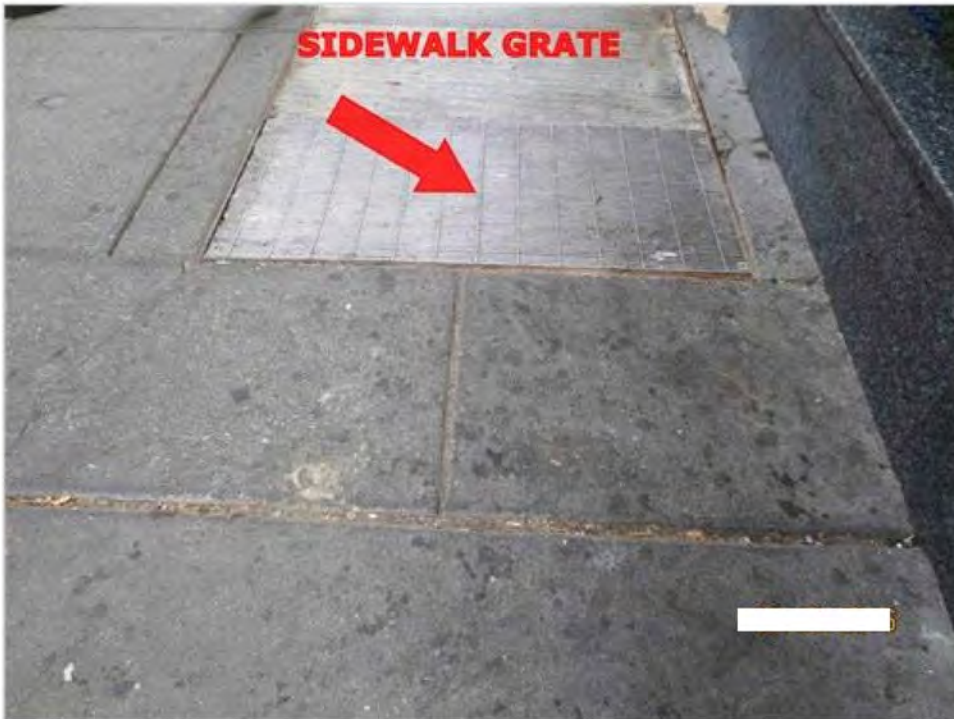
Location That Witness

Indicated The Claimant Landed After Stumbling / Falling

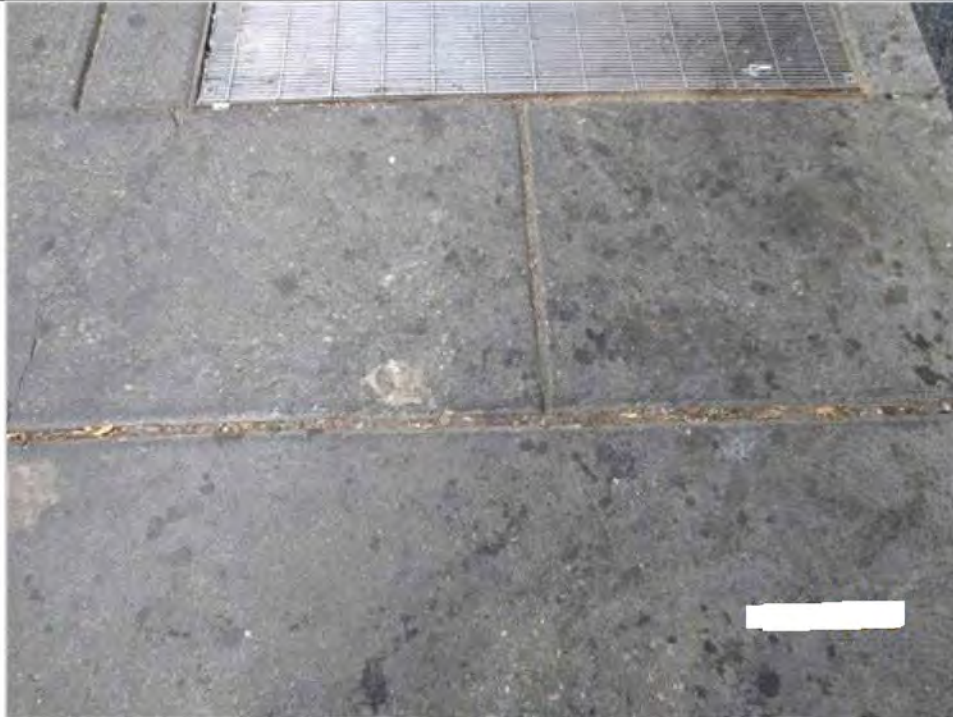
Expansion Joint in Sidewalk

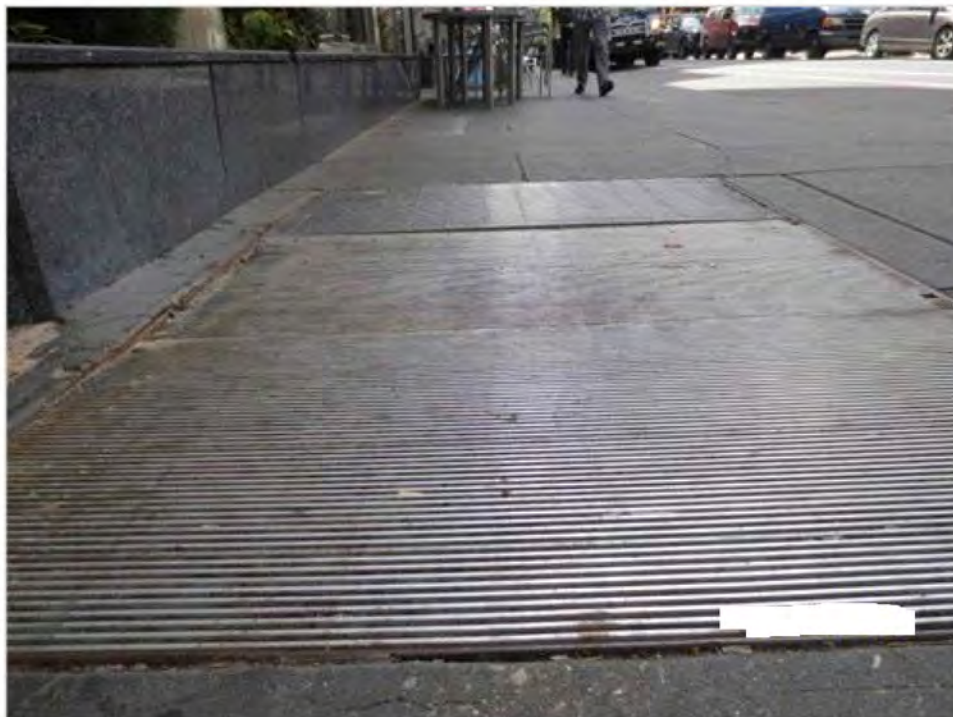
Investigation revealed that the alleged incident occurred on the sidewalk on the _____ side of the restaurant. The sidewalk in that area measures 12' wide and is of concrete construction. The grate in the sidewalk measures 6'5" long by 4'5" wide. At the eastern end it protrudes up 1/2". Refer to the photos below for further details.

Sidewalk Grate / South to North

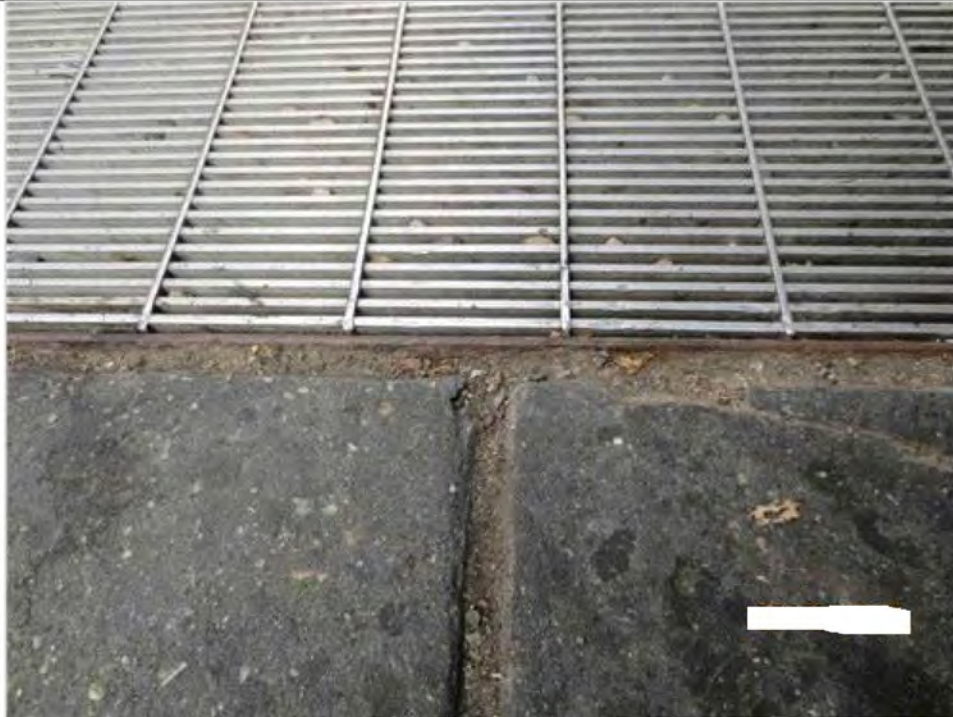
Sidewalk Grate / North to South

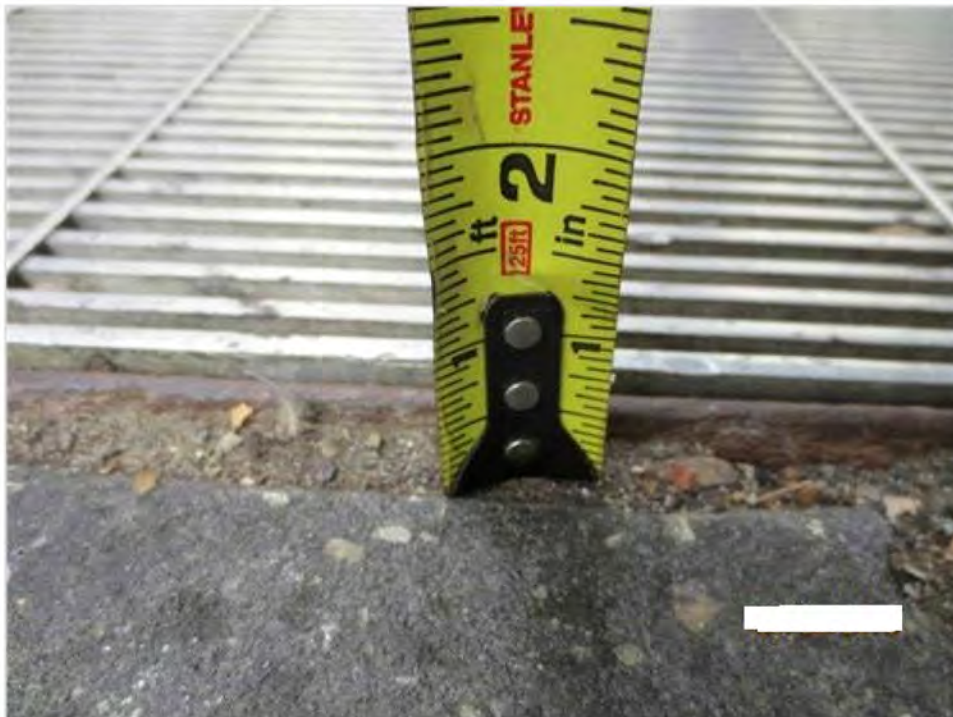
After the [redacted] refused assistance and left he notified his supervisor, [redacted] via the portable radio he carries of what had happened. [redacted] then responded and together they inspected the scene. They noticed that a sidewalk grate was protruding up approximately 1/2 inch. They then repositioned it so it was flush. They both then went back to their office and documented what had transpired in a company incident report.

Slight Elevation of Sidewalk Grate

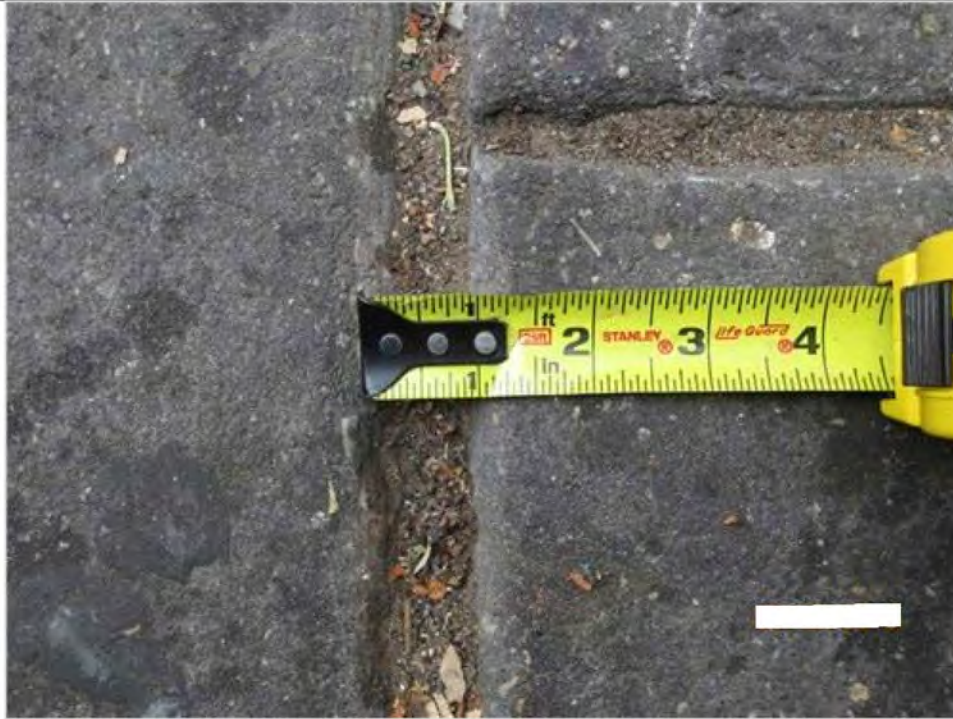
Sidewalk Expansion Joint

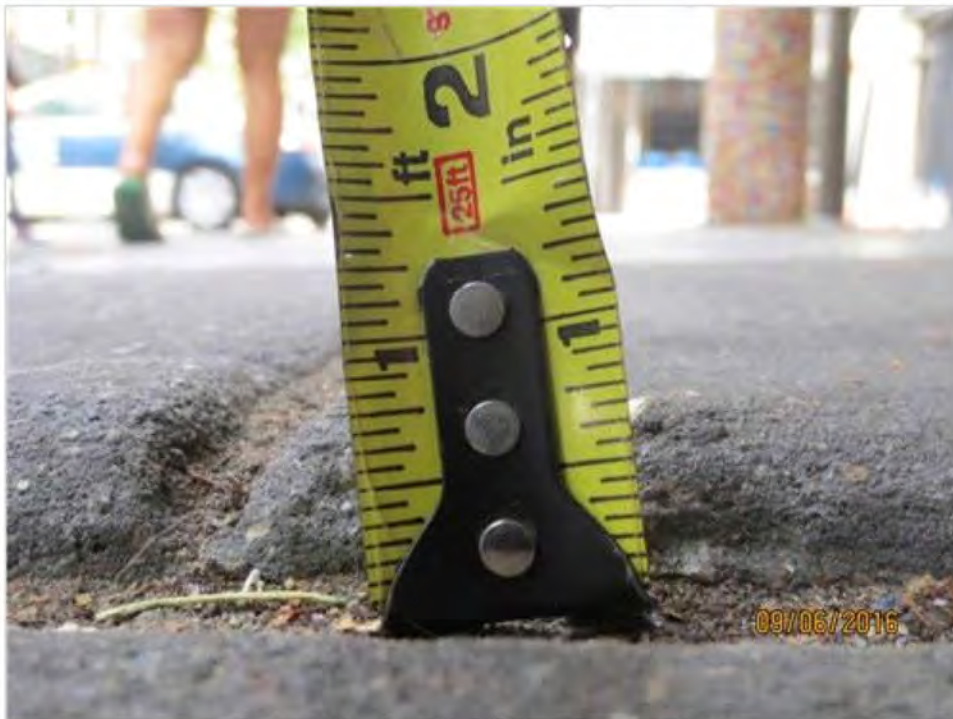
Height of Sidewalk Expansion Joint / North to South

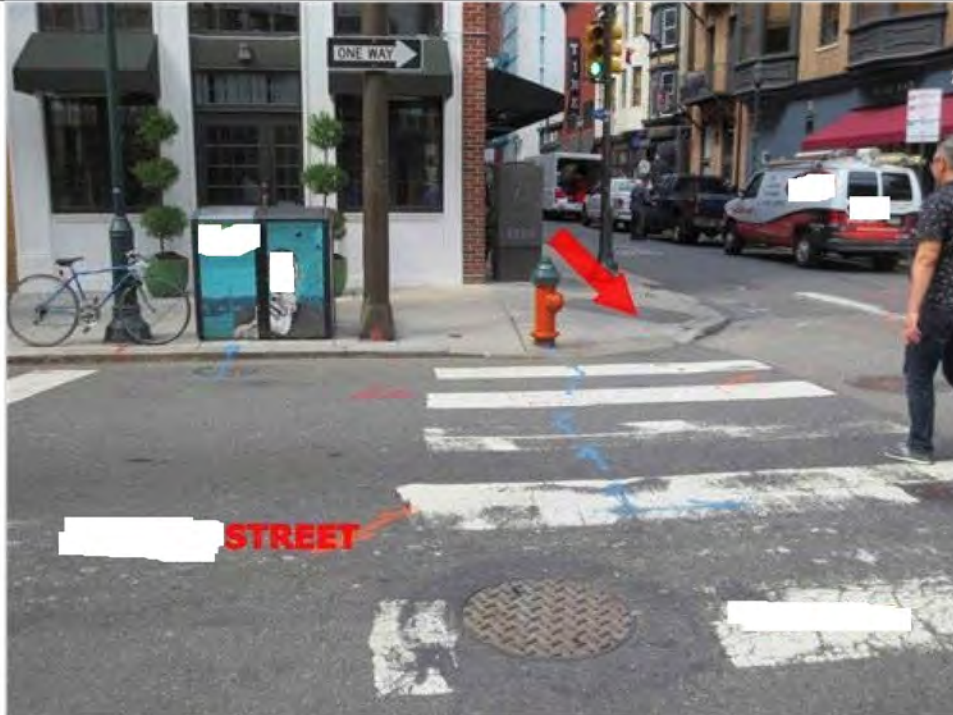
Location Where Witness was Standing at Time of Incident / Looking East to West

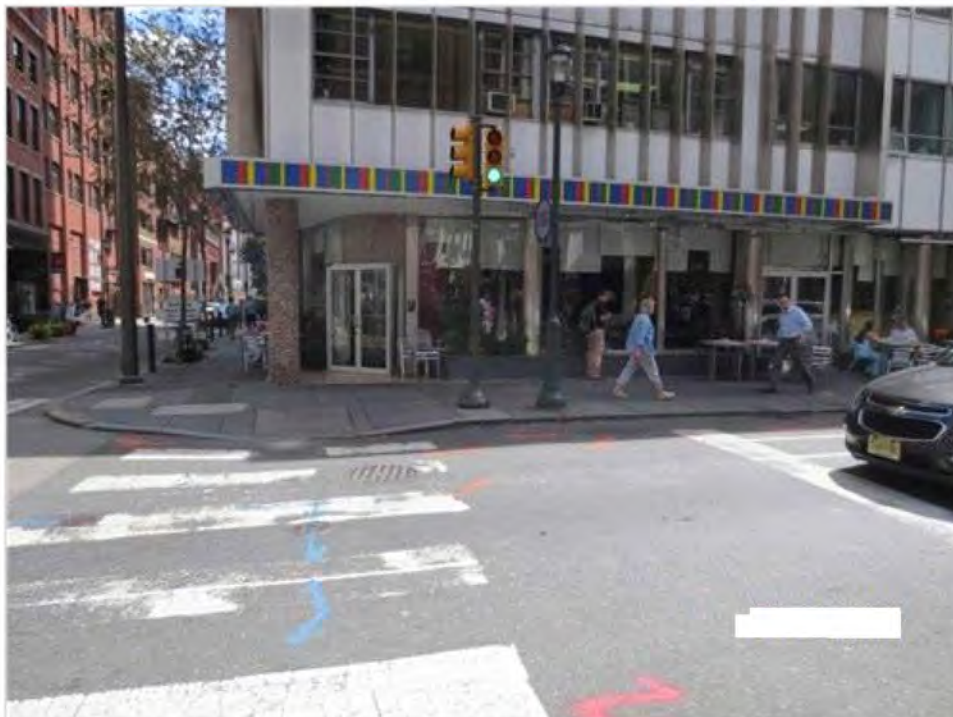
View - West to East of Sidewalk Area From Location Where Witness Was Standing When Incident Occurred

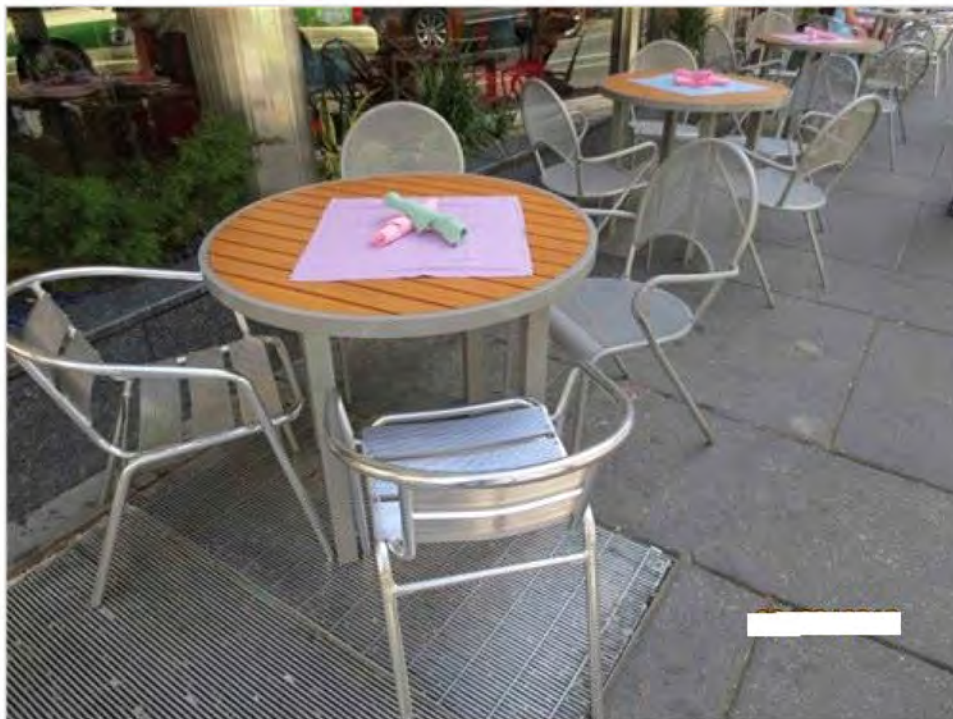
It should be noted that during the restaurant's opening hours, they have outdoor seating on the sidewalk area, thus some furniture is visible in some of the photographs. A copy of the lease is attached for review.

Outdoor Dining Furniture / Set Up During Opening Hours
