Claim Number:	<b>123-456-789</b>
Claimant:	<b>John Q. Public</b>
Insured:	<b>Big Enterprises</b>
Date of Loss:	<b>XX/XX/XXXX</b>

Claims Investigation

Claim Detail

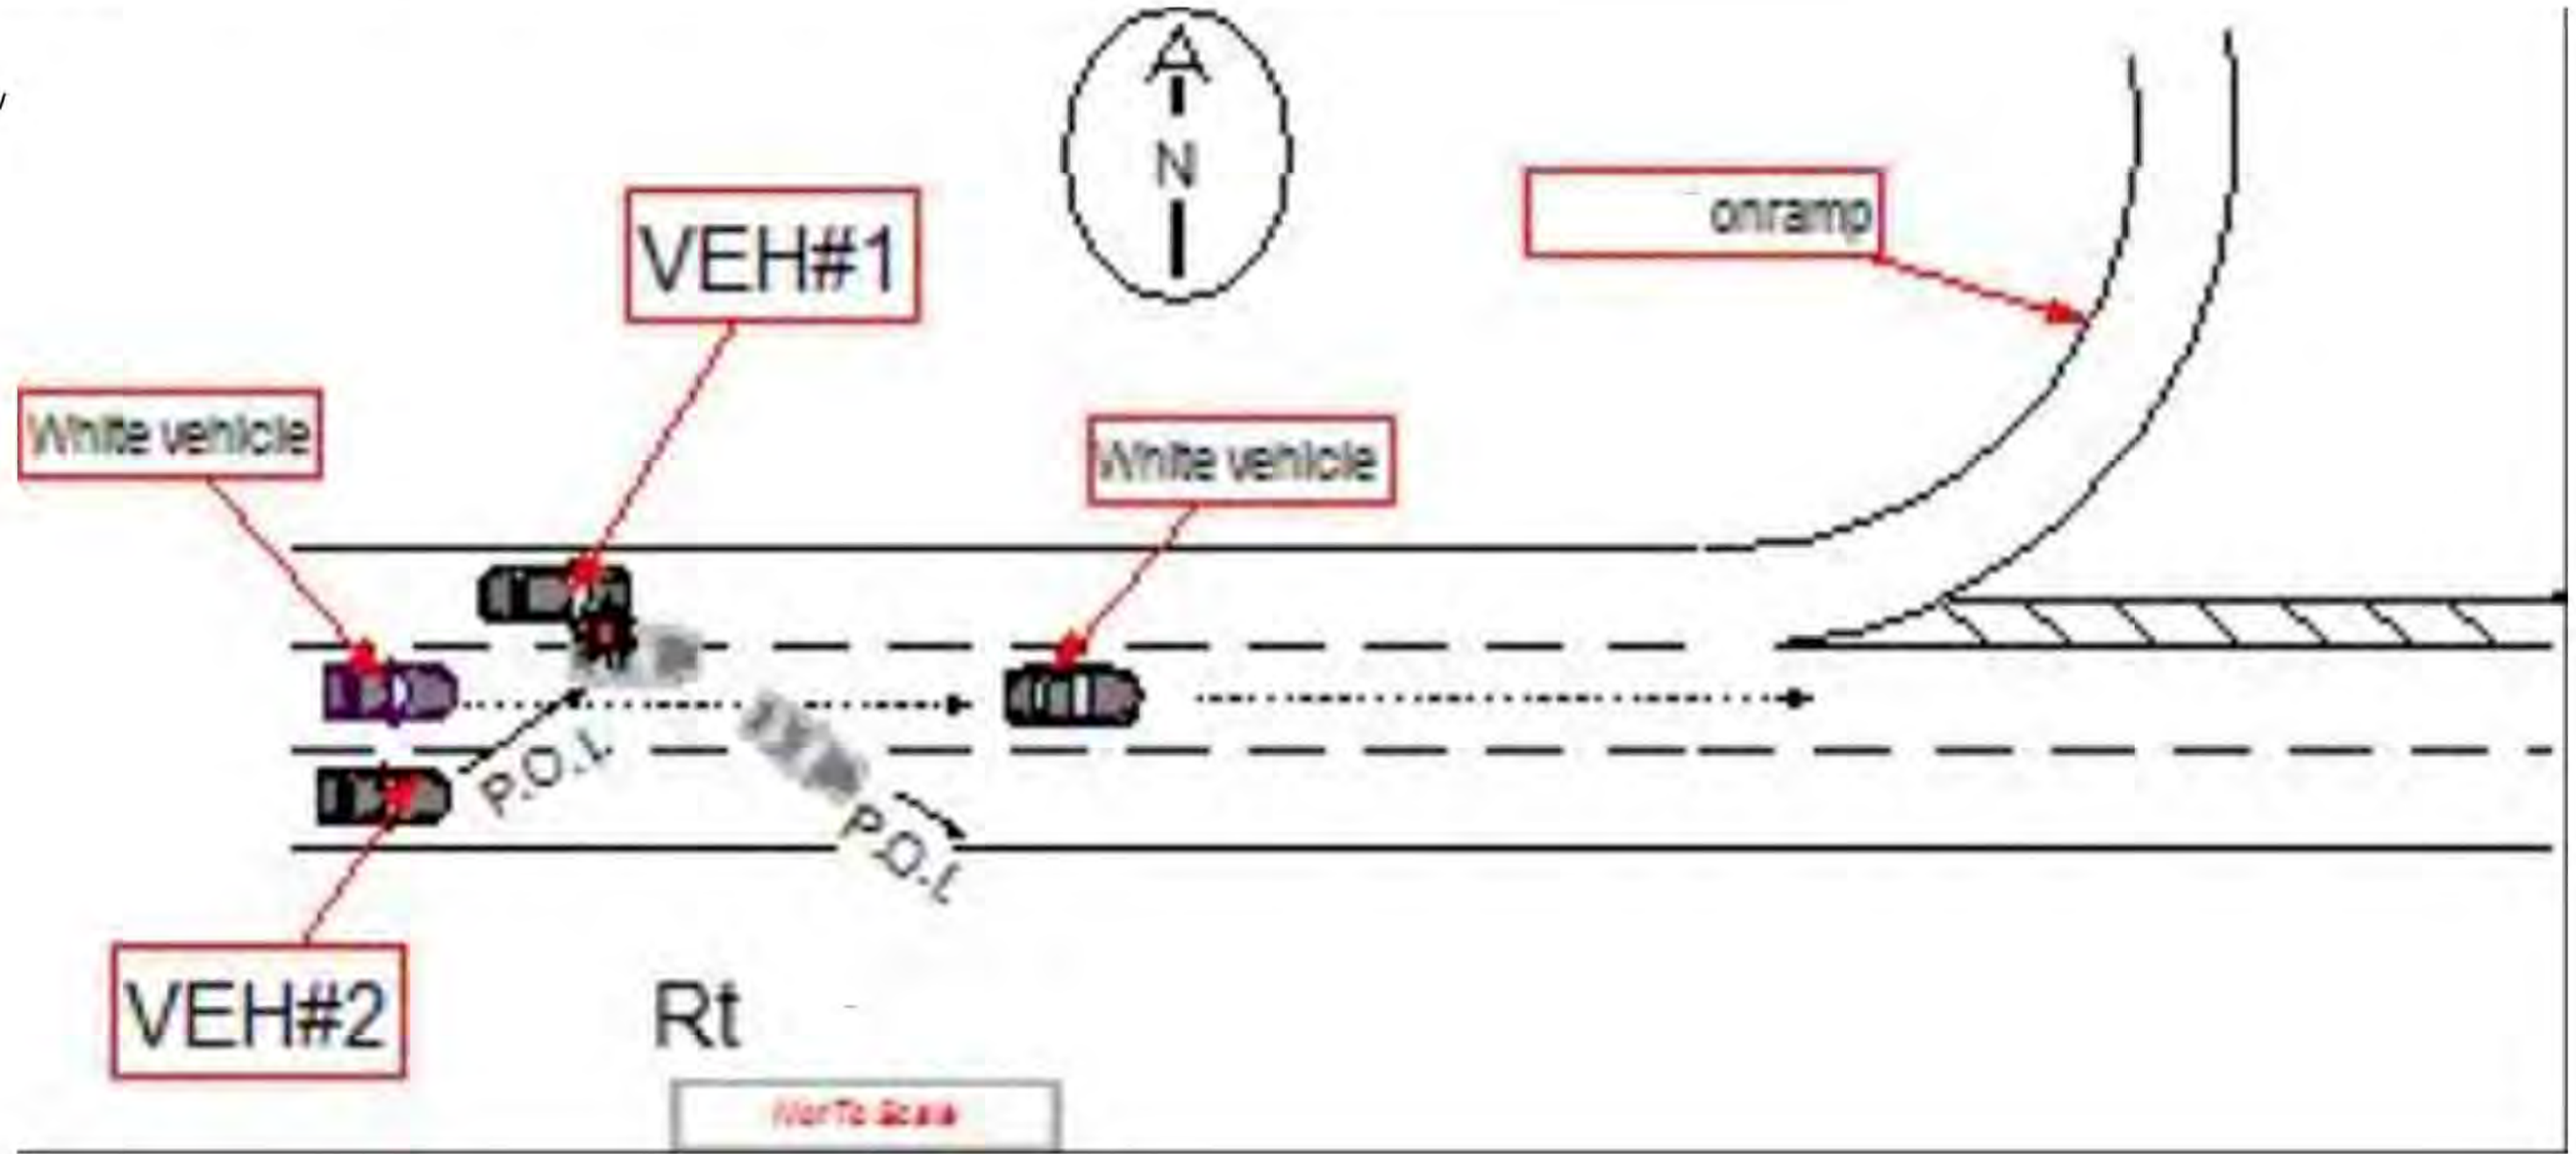
144. Crash Diagram

- In the Crash Diagram, box [redacted], the Officer has identified the off ramp in the left lane of Rt [redacted] as “ [redacted] onramp”
- In the narrative, box [redacted] the Officer, describing Driver #1’s description of the crash stated that, “...vehicle drove up next to [redacted] striking [redacted] on the front driver’s side door / fender”. The damage on V1 clearly shows the point of impact (POI) to be on the passenger side front fender and wheel. (See photos) The Officer correctly identifies V1’s impact area in Boxes [redacted] and [redacted] as “ [redacted] ” which on the diagram shown from the [redacted] (above), is the passenger side door and front fender area.

- The Crash Diagram shows V2 crossing the middle lane and striking V1.

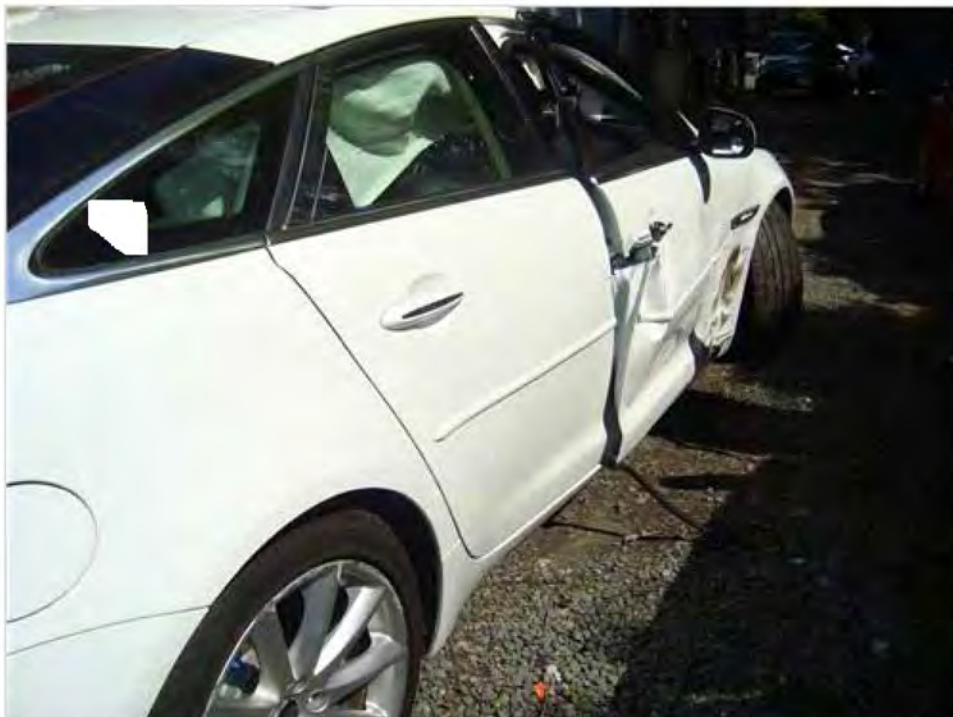
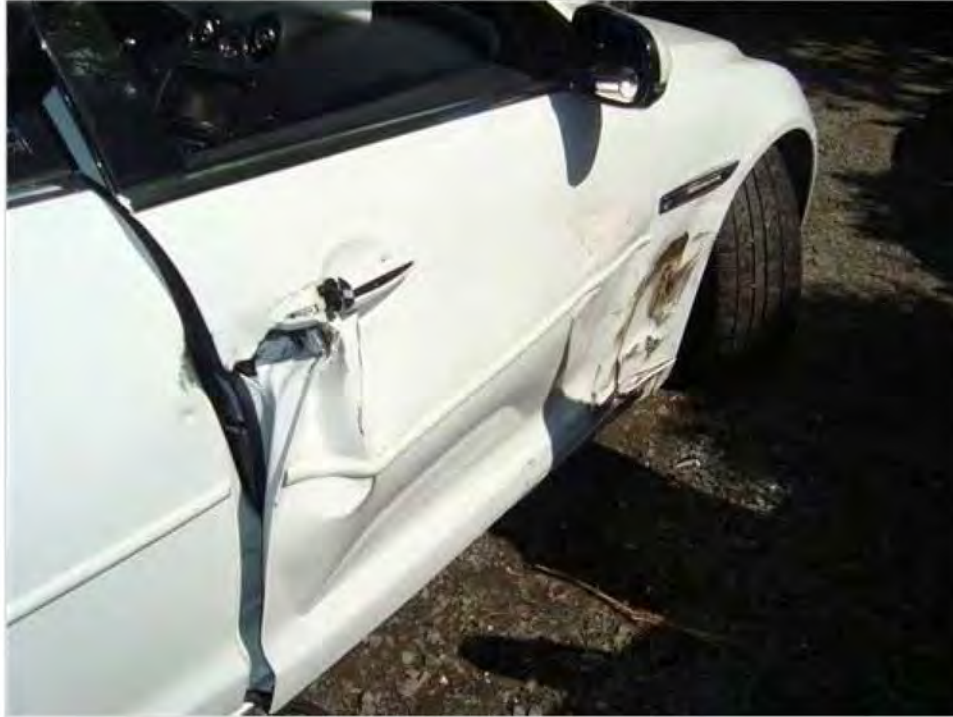
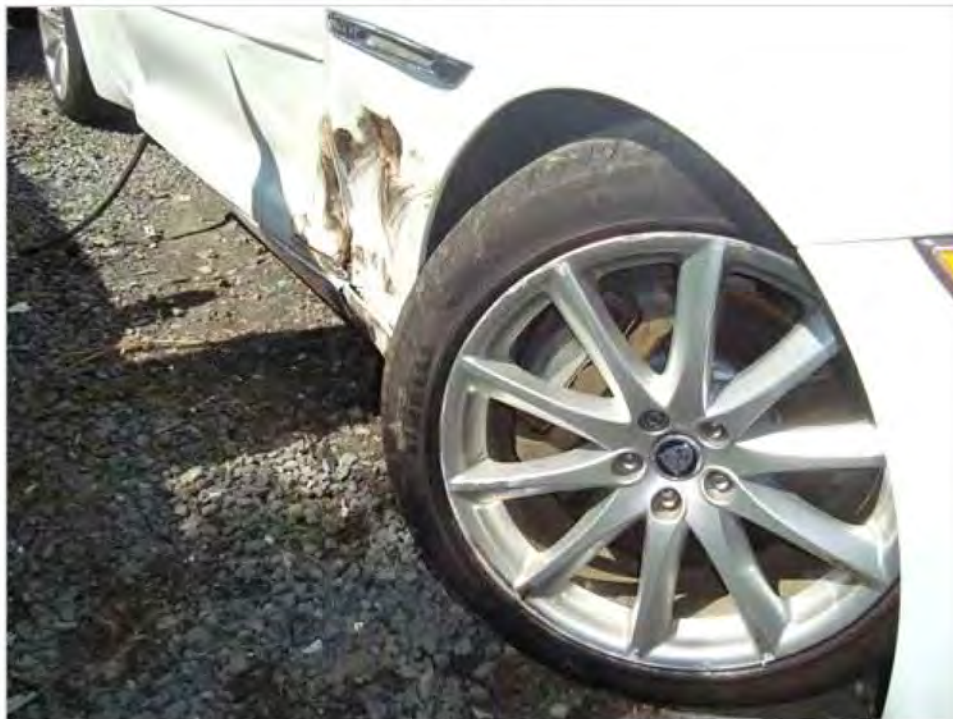
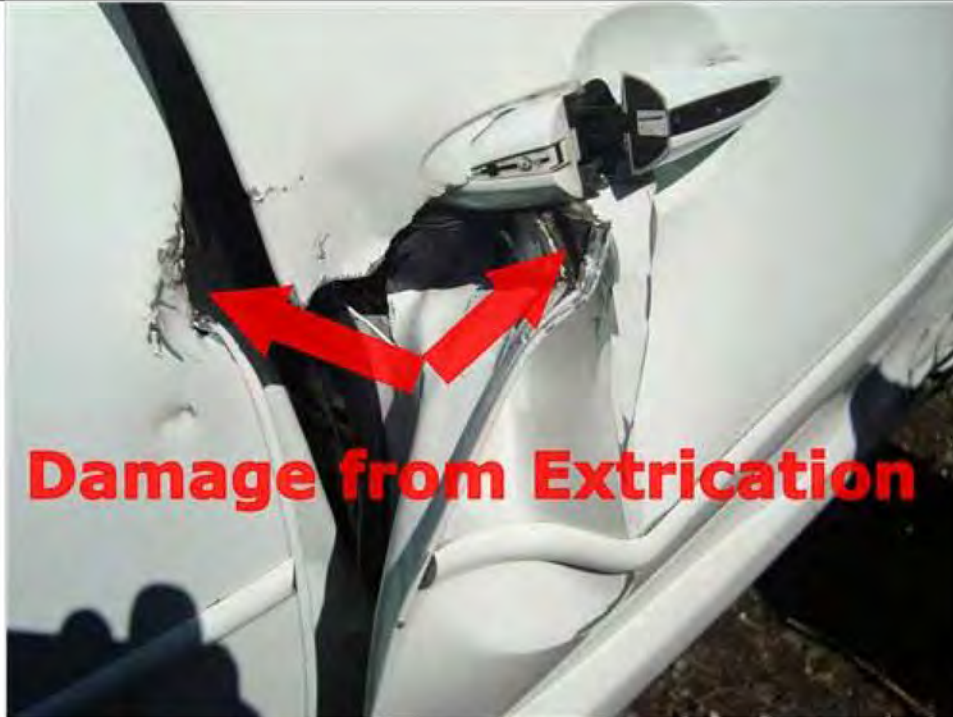
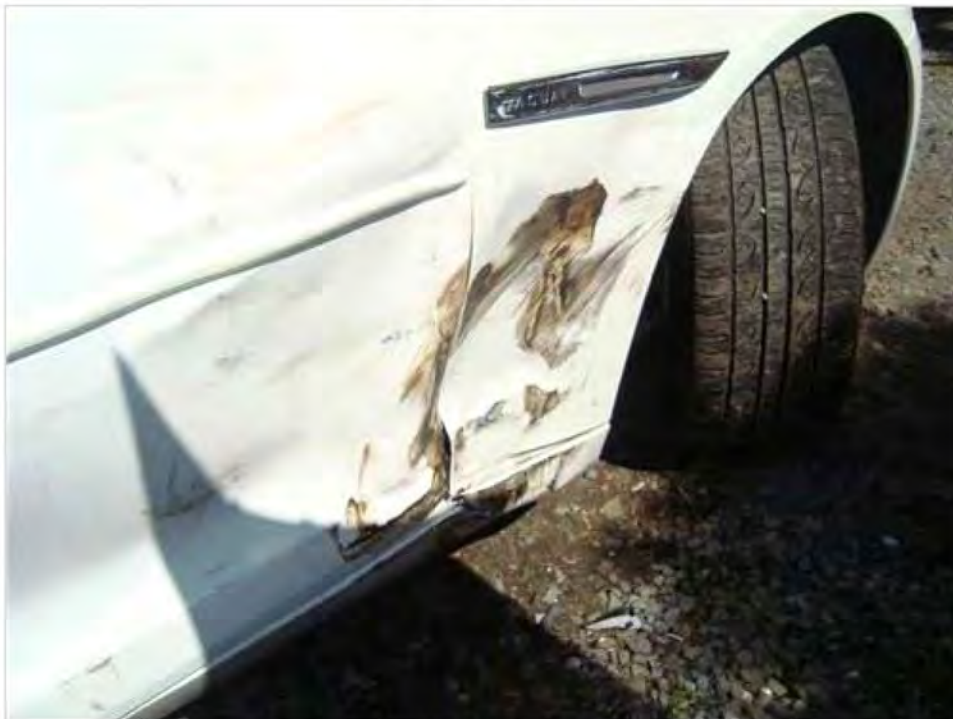
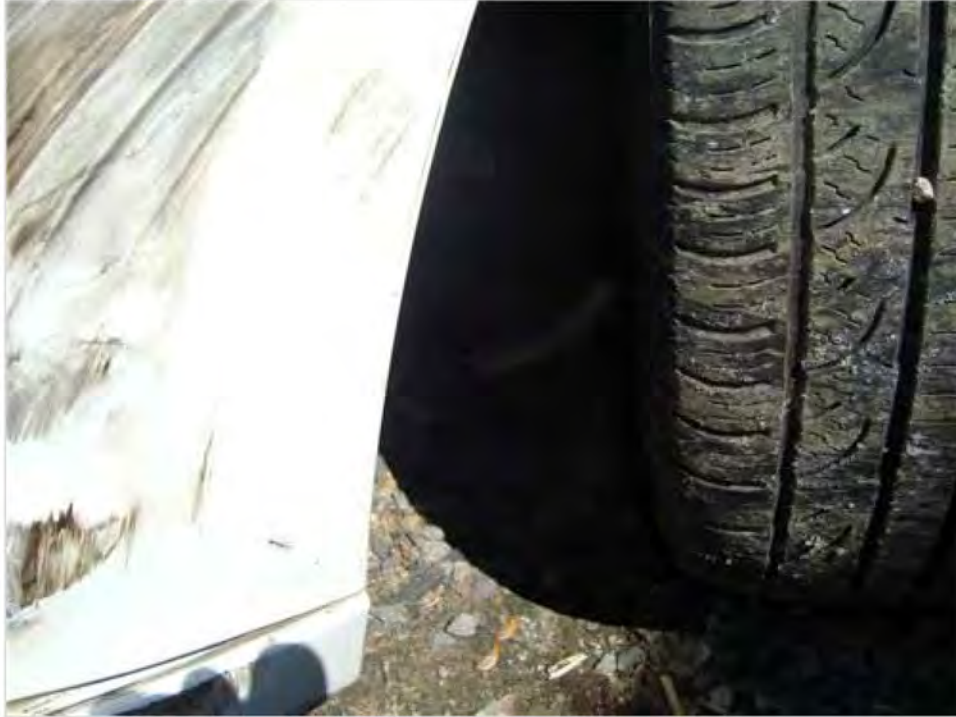
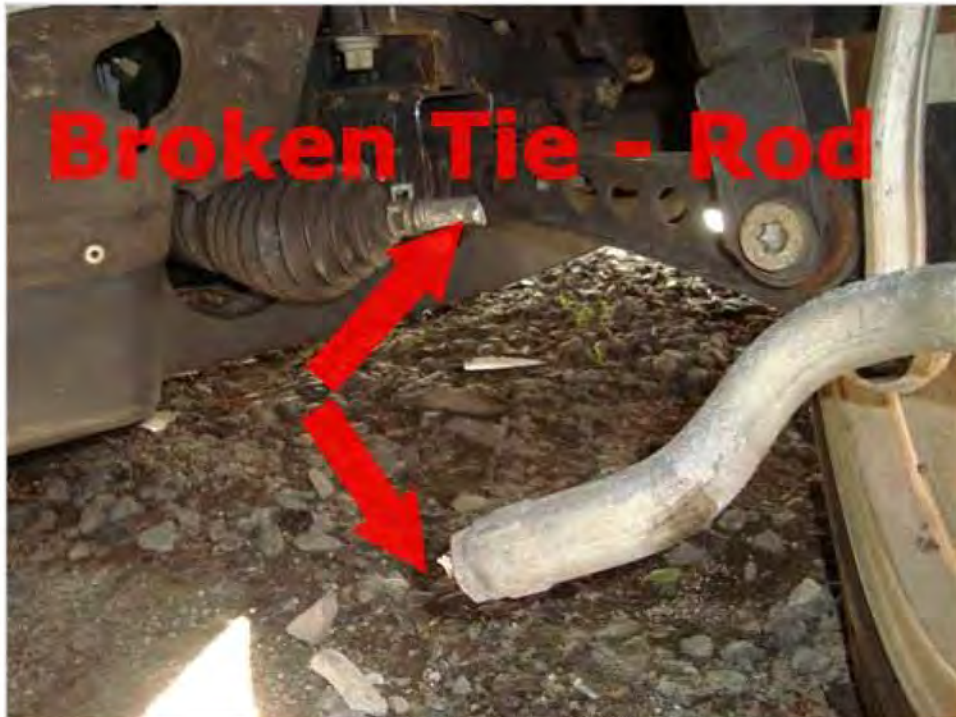
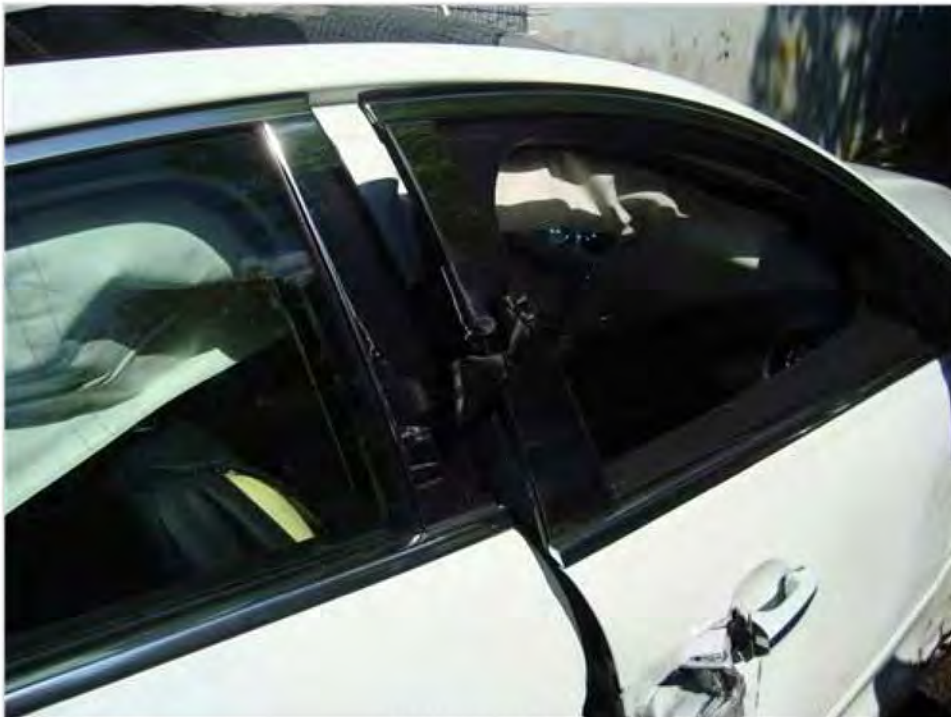
said that a white or grey car sped by her at a high rate of speed while in the middle lane that startled and shook car. Following the white or grey car was V2, also at a high rate of speed, that side swiped her car with its driver's side, rear quarter panel and tire. later found out that the impact to V1's passenger side front fender and tire snapped the tie rod for the tire which greatly affected the steering of V1 and deployed the passenger side airbags.

said pulled to the side of Rt as best could and stopped the car. complained of neck, lower back, and head pain and later had to be extricated from the car by the Fire Dept. using the Jaws of Life. This extrication did significant damage to V1's passenger side front and rear doors. (See V1 Damage View picture showing "Damage from Extrication") said was not injured.

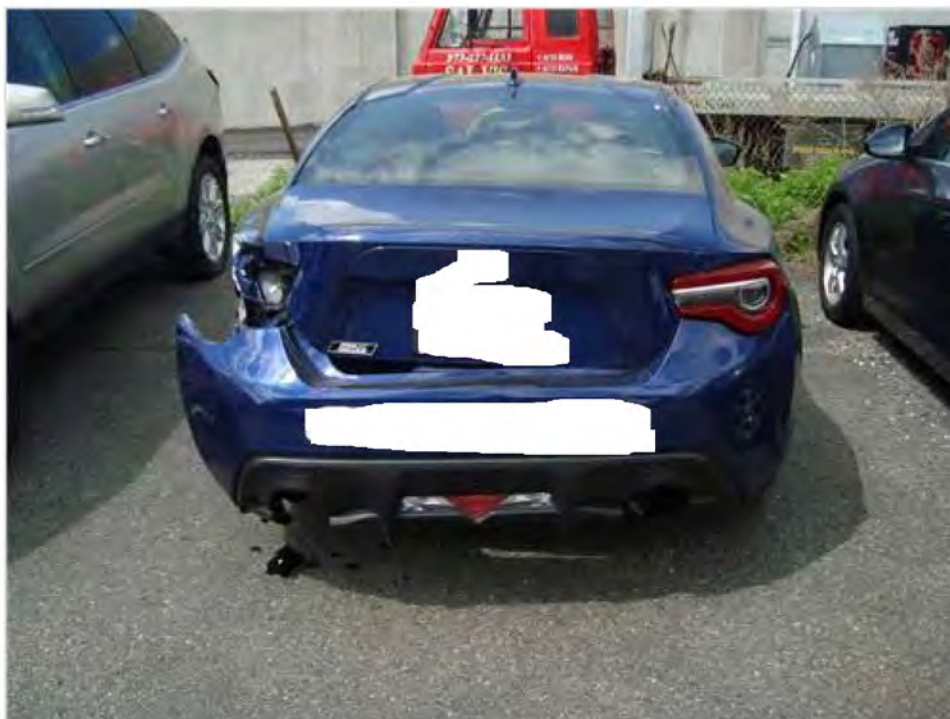
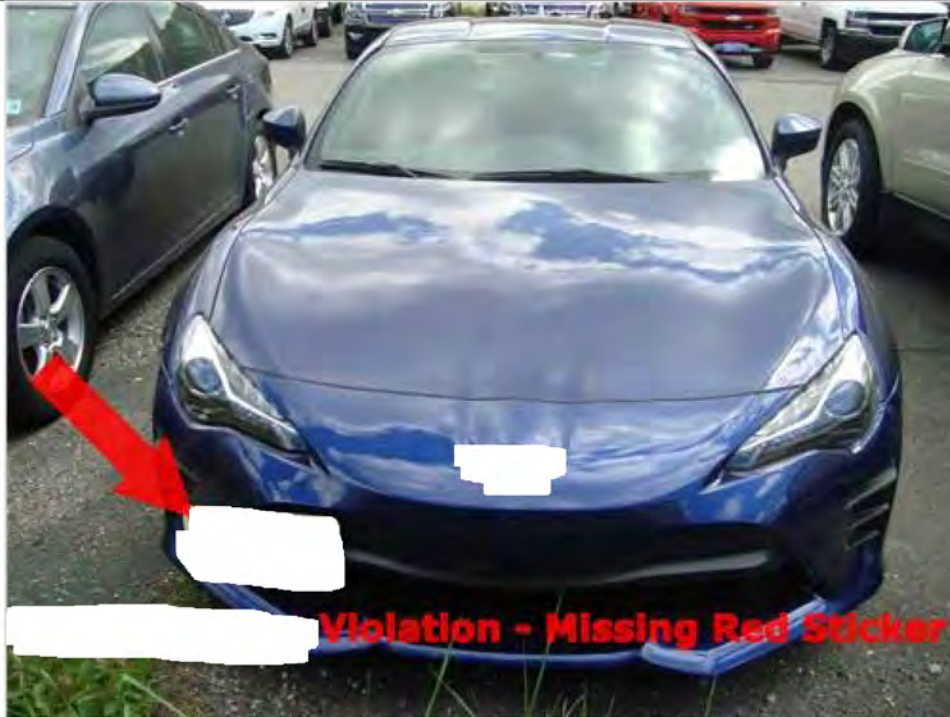
V2 Rear View

- [redacted] (Effective May 10, 2010) states, “ [redacted] stickers must be worn on front and back license plates of the car identifying the bearer as holding a [redacted] ” Clearly missing on the front and rear plate of V2’s license plates are the required stickers. (See Photos)

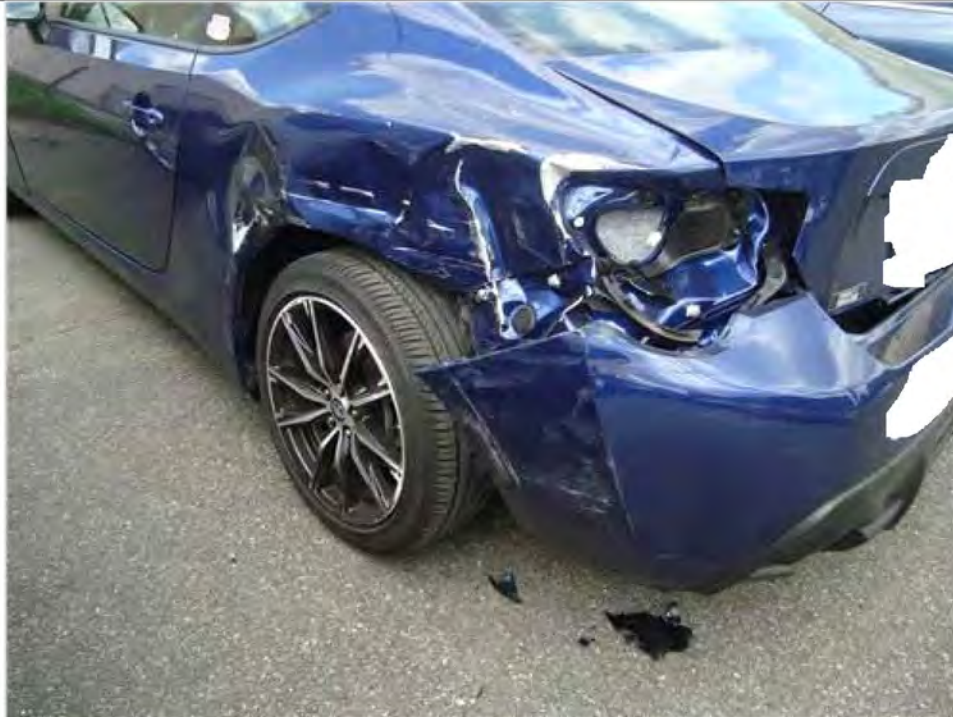
V2 Damage View from Rear

According to [redacted] V1 side swiped his car on the driver's side rear quarter panel and tire with its passenger side front fender and tire which deployed his driver's side airbag.
