Claim Number:	987-654-321
Claimant:	John Q. Public Jr.
Insured:	Restaurant Group
Date of Loss:	XX-XX-XXXX

Claims Investigation

Re: Claim No ICC12345
Claimant John Q. Public, Jr.
Insured Restaurant Group
D/L
Investigation date:

Please select type of loss GL
If GL, please choose type of loss. If more than one loss, please select "other" and explain Slip/Trip Fall
Assignment On I was assigned to conduct an on scene investigation of the above alleged incident, including photographing the scene, identifying and interviewing any witnesses and to determine if any surveillance video exists.
Claim Claimant John Q. Public alleged he tripped and fell on a sewer grate on the sidewalk in front of Restaurant, 123 Main Street, . This allegedly occurred on
Location of Loss
Contact

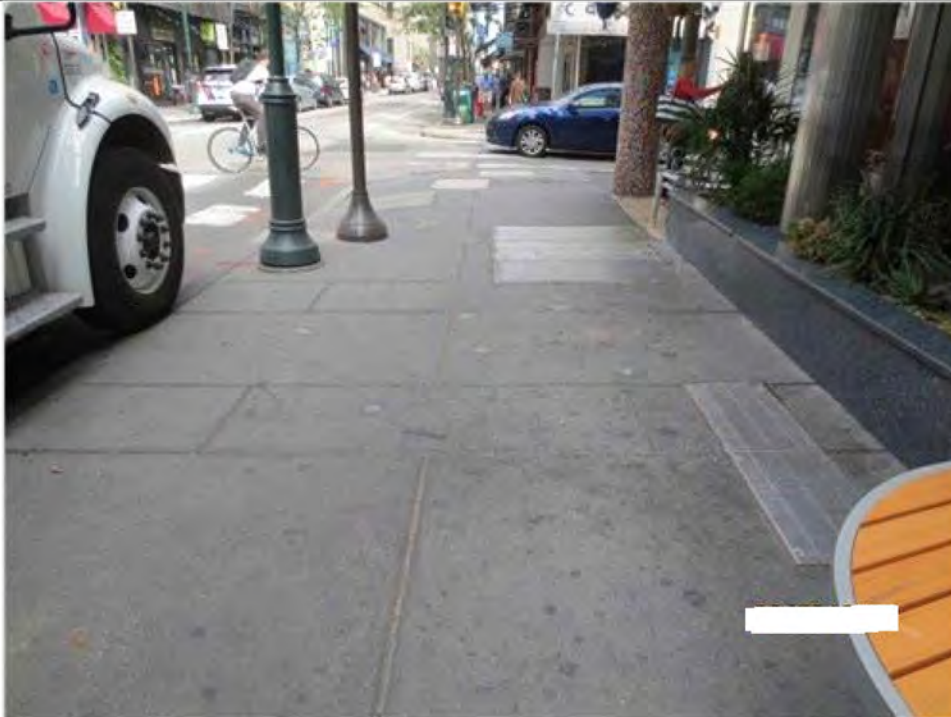
Sidewalk View / North to South

Investigation revealed that the alleged incident occurred on the sidewalk on the _____ side of the restaurant. The sidewalk in that area measures 12' wide and is of concrete construction. The grate in the sidewalk measures 6'5" long by 4'5" wide. At the eastern end it protrudes up 1/2". Refer to the photos below for further details.
